**Flood Control Project Maintenance
Levee Inspections**
LMA District Cover Sheet
Spring 2014 Levee Inspection Results

San Joaquin County Flood Control and Water Conservation District

Spring 2014 Levee Inspection Results

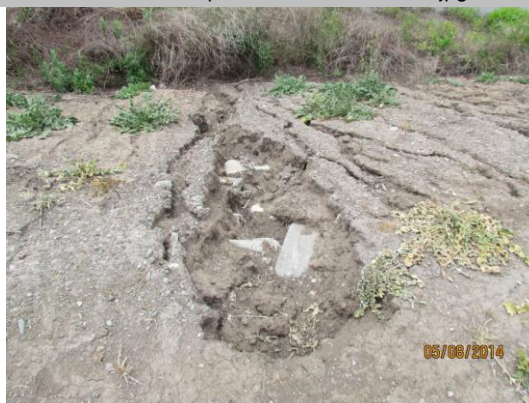
Photo 1 of 1 : pkazi_s_20140509_958.jpg

LM Start	2.24	Rating **	M	Issue No.	4
LM End	2.24	Issue Type +	Ma	Location *	WS
Category	Earthen Levee			GPS Latitude/Longitude	
				Start	End
Item	Erosion / Bank Caving			37.884741 °	37.884741 °
				-121.253808 °	-121.253808 °
DWR ID	DWR_NA0017_02_s_2014_4				
Action/Comments					
Schedule repair of erosion site prior to the next inspection.

Erosion was found on the waterside slope of the levee looking downstream.

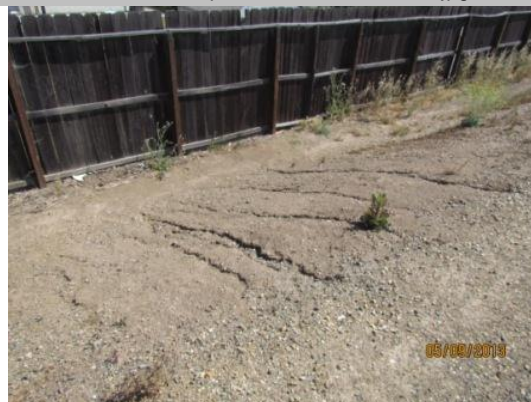
Photo 1 of 1 : pkazi_s_20140415_113.jpg

LM Start	0.92	Rating **	M	Issue No.	2
LM End	0.92	Issue Type +	Ma	Location *	LS
Category	Earthen Levee			GPS Latitude/Longitude	
				Start	End
Item	Erosion / Bank Caving			38.043468 °	38.043468 °
				-121.361022 °	-121.361022 °
DWR ID	DWR_NA0017_07_s_2013_2				
Action/Comments					
Schedule repair of erosion site prior to the next inspection.

Erosion was found on the landside of the levee looking upstream.

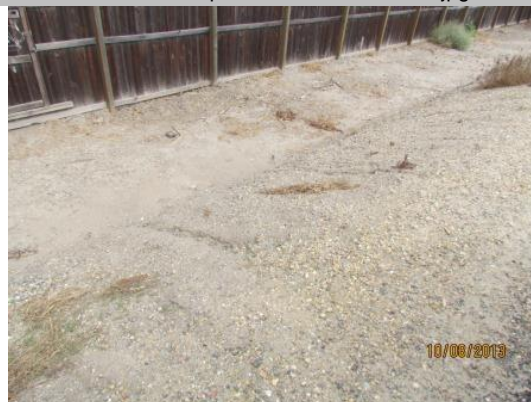
Photo 1 of 1 : pkazi_s_20140415_119.jpg

LM Start	1.17	Rating **	M	Issue No.	9
LM End	1.17	Issue Type +	Ma	Location *	LS
Category	Earthen Levee			GPS Latitude/Longitude	
				Start	End
Item	Erosion / Bank Caving			38.043350 °	38.043350 °
				-121.356491 °	-121.356491 °
DWR ID	DWR_NA0017_07_f_2013_9				
Action/Comments					
Schedule repair of erosion site prior to the next inspection. Inspector Comments: Runoff damage on the landside slope.

Runoff was discovered on the landside slope of the levee looking upstream.

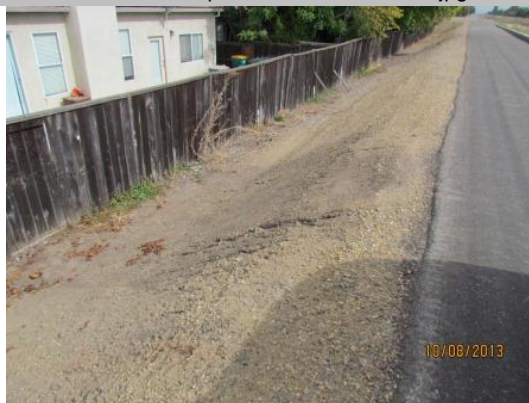
Photo 1 of 1 : pkazi_s_20140415_121.jpg

LM Start	1.94	Rating **	M	Issue No.	11
LM End	1.94	Issue Type +	Ma	Location *	LS
Category	Earthen Levee			GPS Latitude/Longitude	
				Start	End
Item	Erosion / Bank Caving			38.043276 °	38.043276 °
				-121.342812 °	-121.342812 °
DWR ID	DWR_NA0017_07_f_2013_11				
Action/Comments					
Schedule repair of erosion site prior to the next inspection. Inspector Comments: Runoff on the landside slope.

Runoff was discovered on the landside slope of the levee looking upstream.

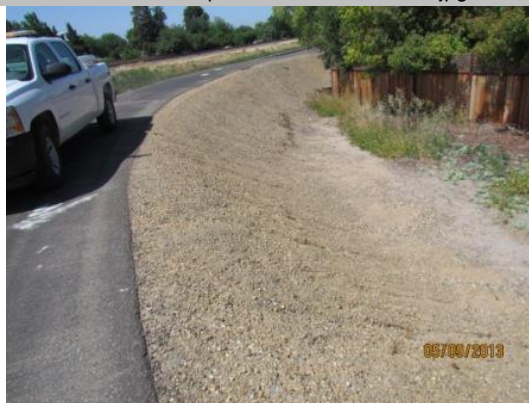
Photo 1 of 1 : pkazi_s_20140415_115.jpg

LM Start	1.99	Rating **	M	Issue No.	4
LM End	1.99	Issue Type +	Ma	Location *	LS
Category	Earthen Levee			GPS Latitude/Longitude	
				Start	End
Item	Erosion / Bank Caving			38.043316 °	38.043316 °
				-121.341816 °	-121.341816 °
DWR ID	DWR_NA0017_07_s_2013_4				
Action/Comments					
Schedule repair of erosion site prior to the next inspection.

Erosion caused by runoff was found on the landside of the levee looking downstream.

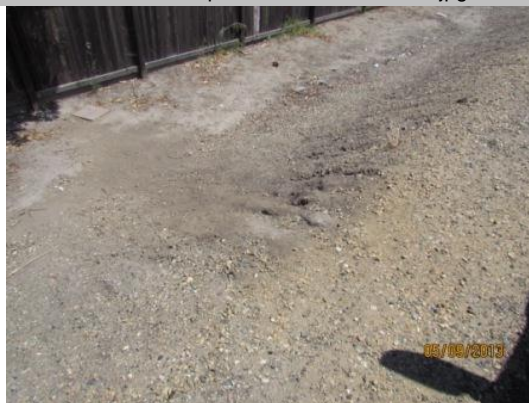
Photo 1 of 1 : pkazi_s_20140415_116.jpg

LM Start	2.08	Rating **	M	Issue No.	5
LM End	2.08	Issue Type +	Ma	Location *	LS
Category	Earthen Levee			GPS Latitude/Longitude	
				Start	End
Item	Erosion / Bank Caving			38.043264 °	38.043264 °
				-121.340292 °	-121.340292 °
DWR ID	DWR_NA0017_07_s_2013_5				
Action/Comments					
Schedule repair of erosion site prior to the next inspection.

Erosion was found on the landside of the levee looking upstream.

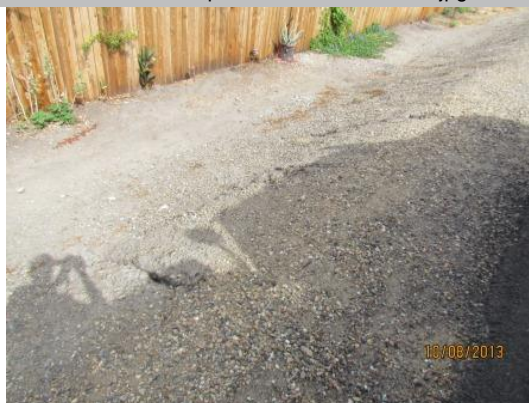
Photo 1 of 1 : pkazi_s_20140415_123.jpg

LM Start	2.27	Rating **	M	Issue No.	14
LM End	2.27	Issue Type +	Ma	Location *	LS
Category	Earthen Levee			GPS Latitude/Longitude	
				Start	End
Item	Erosion / Bank Caving			38.043230 °	38.043230 °
				-121.336707 °	-121.336707 °
DWR ID	DWR_NA0017_07_f_2013_14				
Action/Comments					
Schedule repair of erosion site prior to the next inspection. Inspector Comments: Runoff on the landside slope of the levee.

Runoff was found on the landside slope of the levee looking upstream.

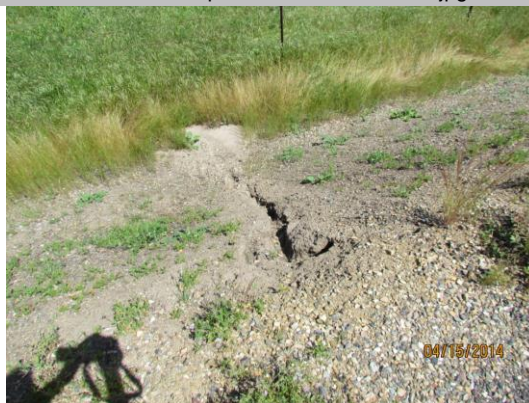
Photo 1 of 1 : pkazi_s_20140418_868.jpg

LM Start	2.88	Rating **	M	Issue No.	17
LM End	2.88	Issue Type +	Ma	Location *	LS
Category	Earthen Levee			GPS Latitude/Longitude	
				Start	End
Item	Erosion / Bank Caving			38.043154 °	38.043154 °
				-121.325942 °	-121.325942 °
DWR ID	DWR_NA0017_07_s_2014_17				
Action/Comments					
Schedule repair of erosion site prior to the next inspection.

An erosion was found on the landside slope of the levee looking upstream.

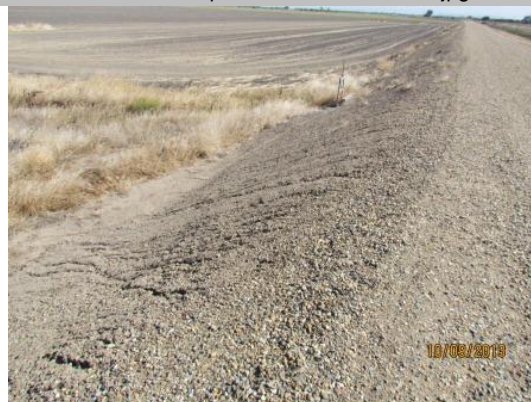
Photo 1 of 1 : pkazi_s_20140415_130.jpg

LM Start	3.78	Rating **	M	Issue No.	24
LM End	3.78	Issue Type +	Ma	Location *	LS
Category	Earthen Levee			GPS Latitude/Longitude	
				Start	End
Item	Erosion / Bank Caving			38.043025 °	38.043025 °
				-121.309918 °	-121.309918 °
DWR ID	DWR_NA0017_07_f_2013_24				
Action/Comments					
Schedule repair of erosion site prior to the next inspection. Inspector Comments: Runoff was discovered.

Erosion occurred due to runoff on the landside slope of the levee looking upstream.

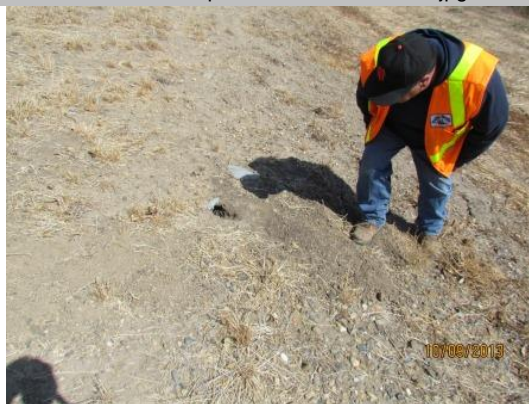
Photo 1 of 1 : pkazi_s_20140415_137.jpg

A rodent hole was found on the waterside of the levee looking upstream.

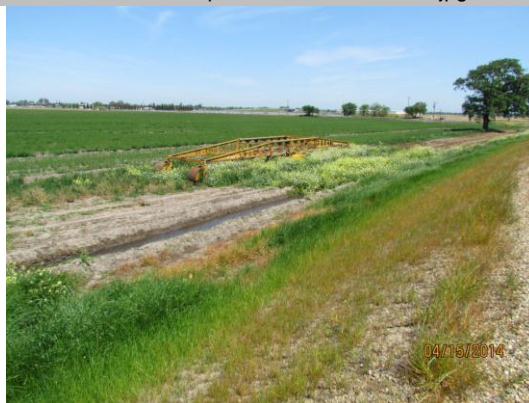
Photo 1 of 1 : pkazi_s_20140418_870.jpg

A ditch was found on the landside toe of the levee looking upstream.

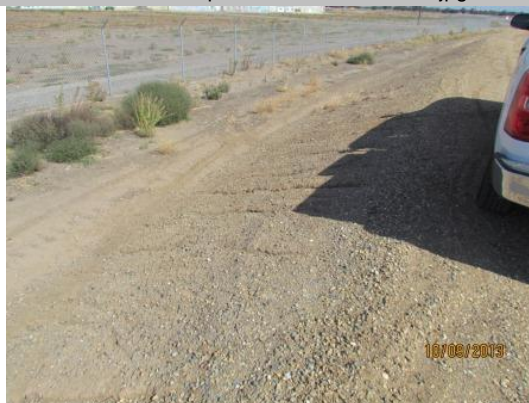
Photo 1 of 1 : pkazi_s_20140415_141.jpg

LM Start	5.89	Rating **	M	Issue No.	43
LM End	5.89	Issue Type +	Ma	Location *	LS
Category	Earthen Levee			GPS Latitude/Longitude	
				Start	End
Item	Erosion / Bank Caving			38.052794 °	38.052794 °
				-121.277035 °	-121.277035 °
DWR ID	DWR_NA0017_07_f_2013_43				
Action/Comments					
Schedule repair of erosion site prior to the next inspection. Inspector Comments: Runoff on the landside.

Runoff was found on the landside slope of the levee looking upstream.

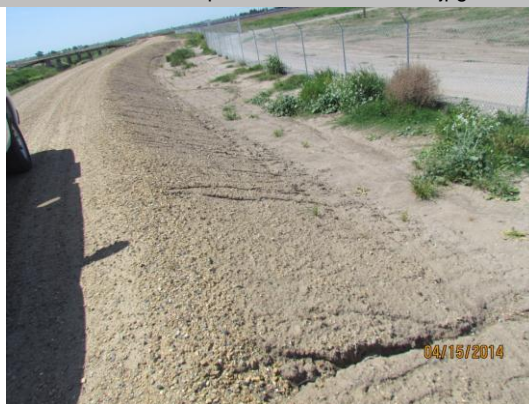
Photo 1 of 1 : pkazi_s_20140418_871.jpg

LM Start	5.98	Rating **	M	Issue No.	40
LM End	5.98	Issue Type +	Ma	Location *	LS
Category	Earthen Levee			GPS Latitude/Longitude	
				Start	End
Item	Slope Stability			38.052834 °	38.052834 °
				-121.275254 °	-121.275254 °
DWR ID	DWR_NA0017_07_s_2014_40				
Action/Comments					
Repair slope instability.

View of slope instability on the landside of the levee looking downstream.

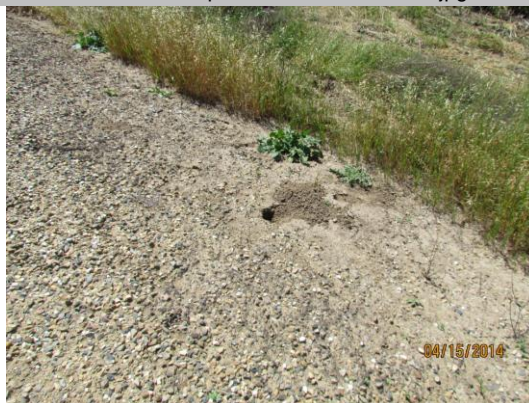
Photo 1 of 1 : pkazi_s_20140418_872.jpg

An animal hole was found on the landside of the levee looking downstream.

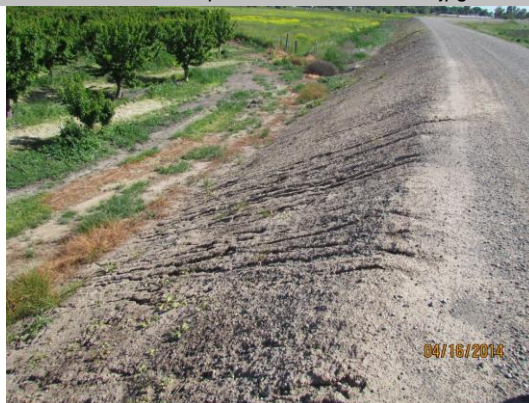
Photo 1 of 1 : pkazi_s_20140418_873.jpg

LM Start	7.48	Rating **	M	Issue No.	27
LM End	7.48	Issue Type +	Ma	Location *	LS
Category	Earthen Levee			GPS Latitude/Longitude	
				Start	End
Item	Erosion / Bank Caving			38.063887 °	38.063887 °
				-121.254949 °	-121.254949 °
DWR ID	DWR_NA0017_07_s _ 2014_27				
Action/Comments					
Schedule repair of erosion site prior to the next inspection.

Erosion caused by runoff on the landside of the levee looking upstream.

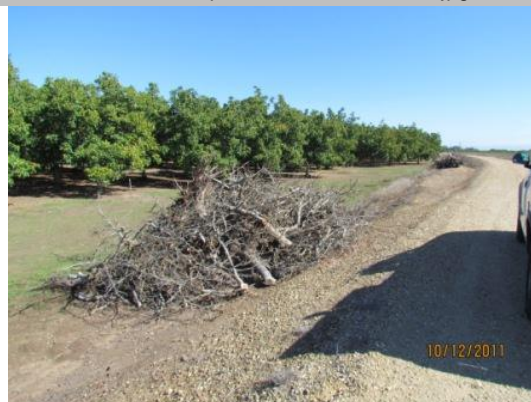
Photo 1 of 1 : pkazi_s_20140415_134.jpg

LM Start	8.87	Rating **	M	Issue No.	29
LM End	8.87	Issue Type +	Ma	Location *	LS
Category	Earthen Levee			GPS Latitude/Longitude	
				Start	End
Item	Encroachments			38.068319 °	38.068319 °
				-121.231559 °	-121.231559 °
DWR ID	DWR_NA0017_07_s _ 2012_29				
Action/Comments					
Prunings					
Inspector Comments: Burn pile has been burned but new material has been placed.

Prunings were found on the landside of the levee looking upstream.

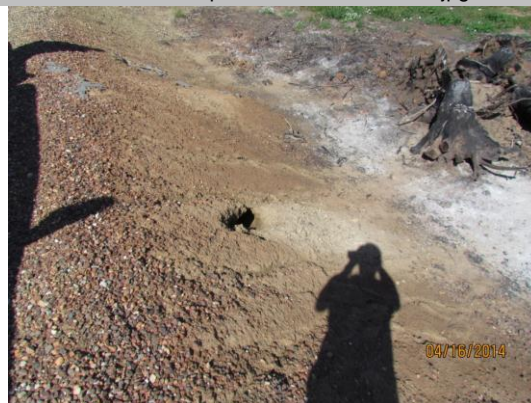
Photo 1 of 1 : pkazi_s_20140418_874.jpg

A rodent hole was found on the landside of the levee looking downstream.

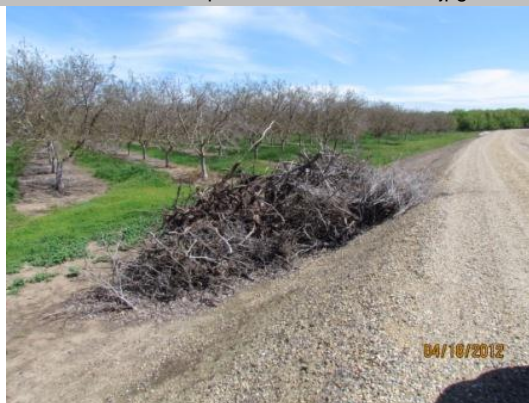
Photo 1 of 1 : pkazi_s_20140415_174.jpg

Prunings were found on the landside of the levee looking upstream.

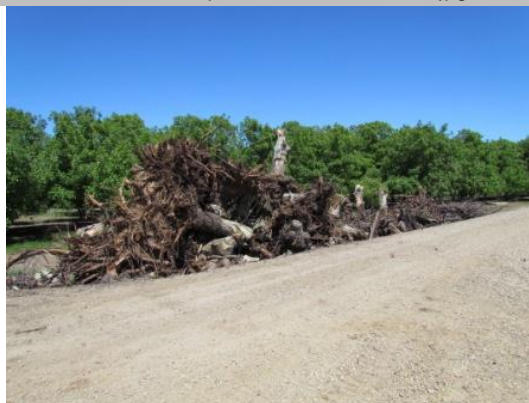
Photo 1 of 2 : pkazi_s_20140415_135.jpg

Burn piles on the landside of the levee. The picture was taken from the crown of the levee looking upstream.

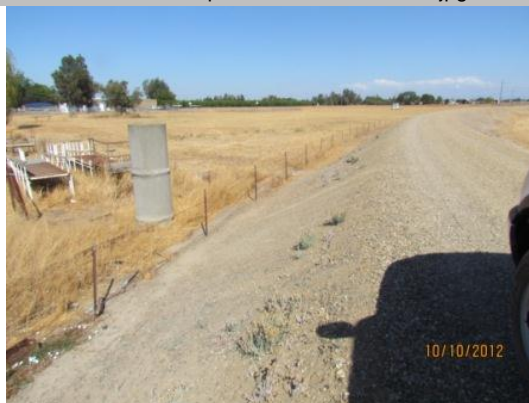
Photo 1 of 1 : pkazi_s_20140415_144.jpg

Fence was found on the landside toe of the levee looking upstream.

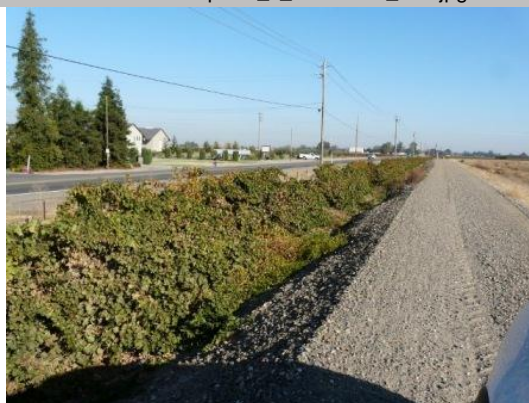
Photo 1 of 1 : pkazi_s_20140415_138.jpg

Grape vines within 10' from landside toe of levee from LM 13.39 to 13.51.

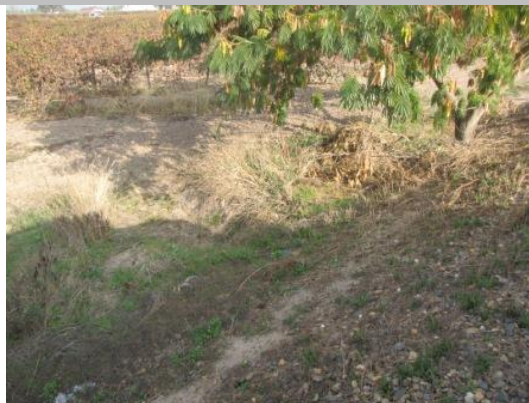
Photo 1 of 1 : pkazi_s_20140415_159.jpg

View of a pit along the landward levee toe looking upstream.

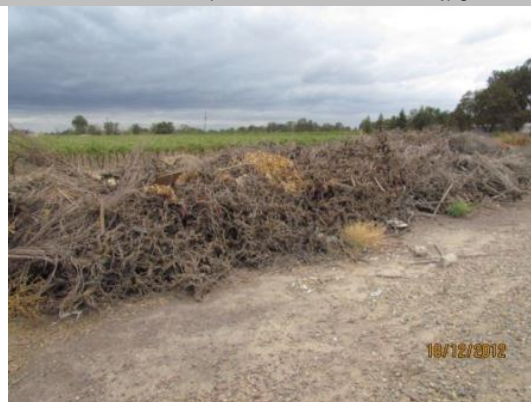
Photo 1 of 1 : pkazi_s_20140415_151.jpg

Prunings were found on the landside of the levee. The picture was taken from the crown looking towards the toe of the levee.

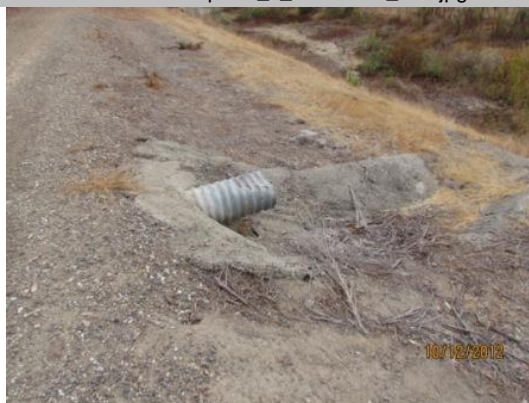
Photo 2 of 2 : pkazi_s_20140415_162.jpg

A pipe was found on the waterside shoulder of the levee looking upstream.

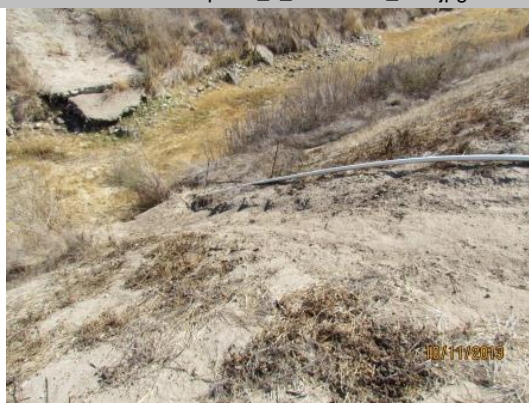
Photo 1 of 1 : pkazi_s_20140415_154.jpg

Steps were found on the waterside slope of the levee looking downstream.

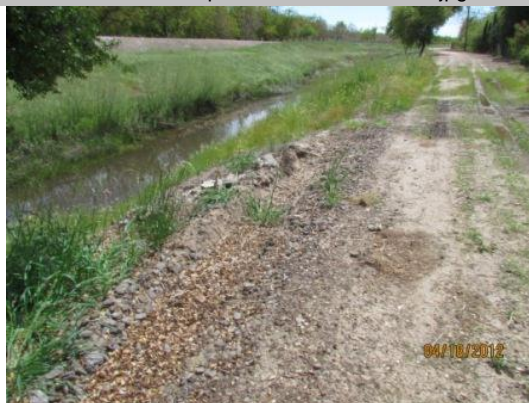
Photo 1 of 1 : pkazi_s_20140415_153.jpg

Crown depression was found on the waterside shoulder of the levee looking downstream.

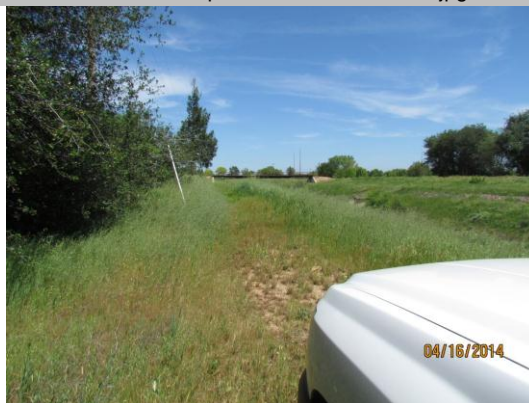
Photo 1 of 1 : pkazi_s_20140418_876.jpg

Vegetation was found on the crown looking upstream.

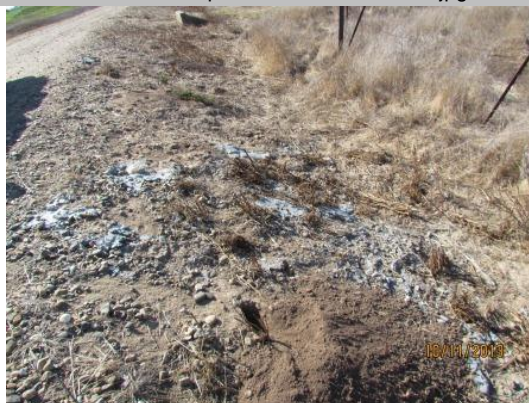
Photo 1 of 1 : pkazi_s_20140415_155.jpg

Animal holes were found on the landside of the levee looking downstream.

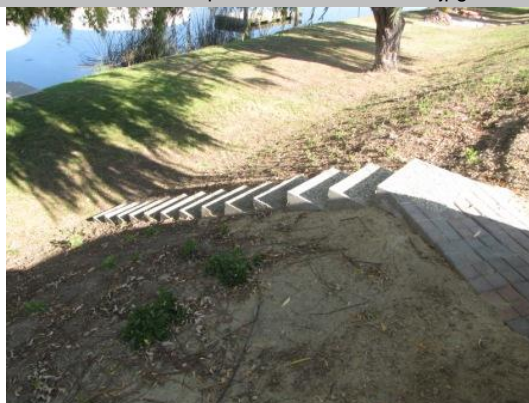
Photo 1 of 1 : pkazi_s_20140415_249.jpg

View of steps on the waterward slope of the levee looking upstream.

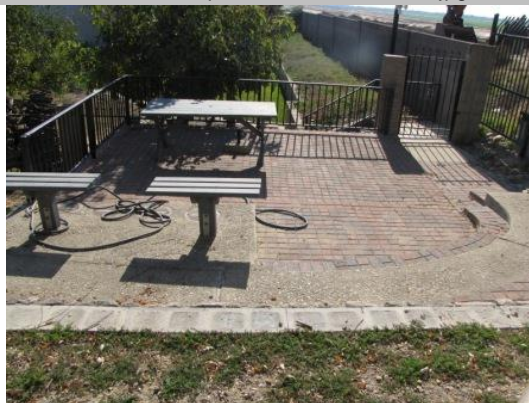
Photo 1 of 1 : pkazi_s_20140415_250.jpg

View of a patio with table, benches, and irrigation on the landward side of the levee.

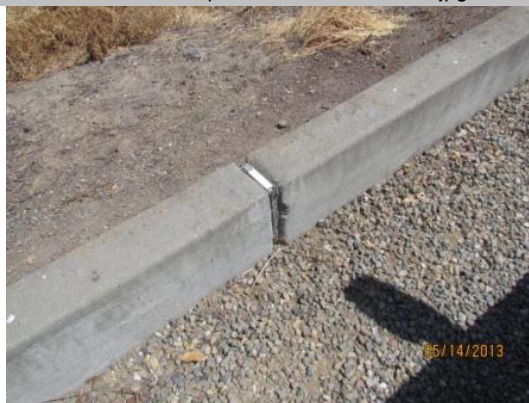
Photo 1 of 1 : pkazi_s_20140415_194.jpg

The monolith joint material is deteriorating at this location of the flood wall. The picture was taken from the crown looking upstream.

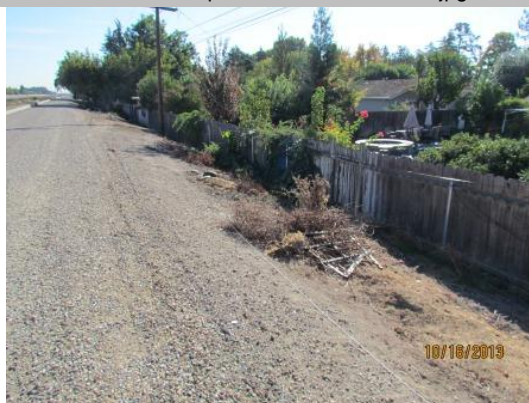
Photo 1 of 1 : pkazi_s_20140415_206.jpg

Prunings were found on the landside toe of the levee looking upstream.

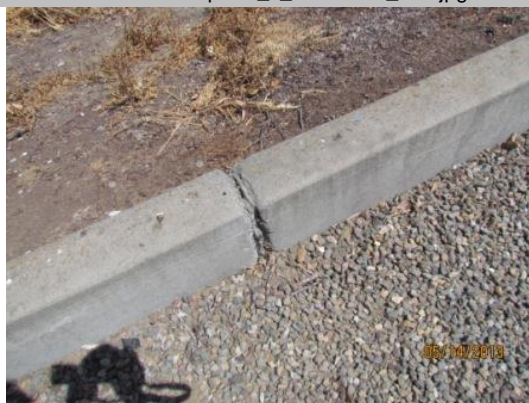
Photo 1 of 1 : pkazi_s_20140415_196.jpg

The monolith joint material is deteriorating at this location of the flood wall. The picture was taken from the crown looking upstream.

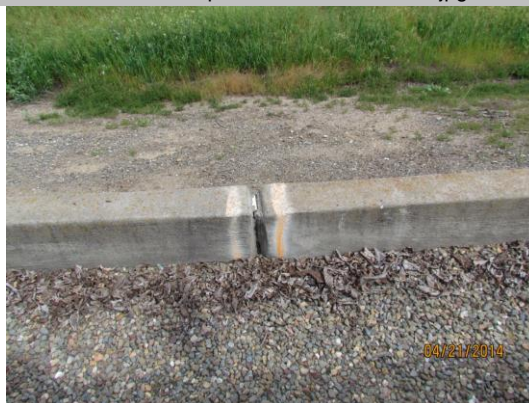
Photo 1 of 1 : pkazi_s_20140428_878.jpg

A deteriorating monolith joint on the wall was found on the waterside of the levee looking upstream.

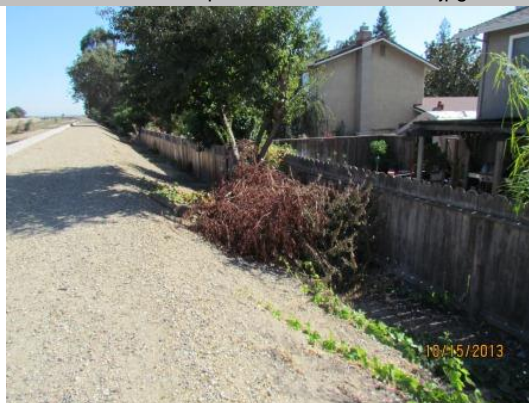
Photo 1 of 1 : pkazi_s_20140415_199.jpg

Prunings were found on the landside toe of the levee looking upstream.

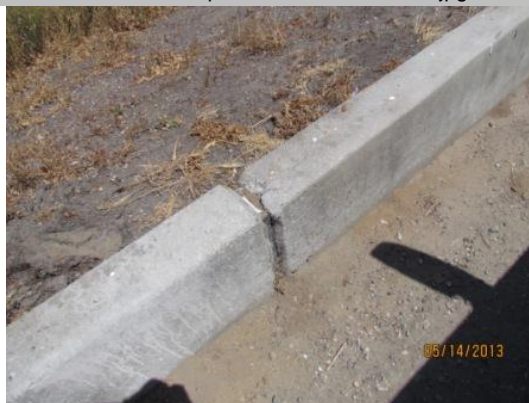
Photo 1 of 1 : pkazi_s_20140415_198.jpg

The monolith joint material is deteriorating at this location of the flood wall. The picture was taken from the crown looking upstream.

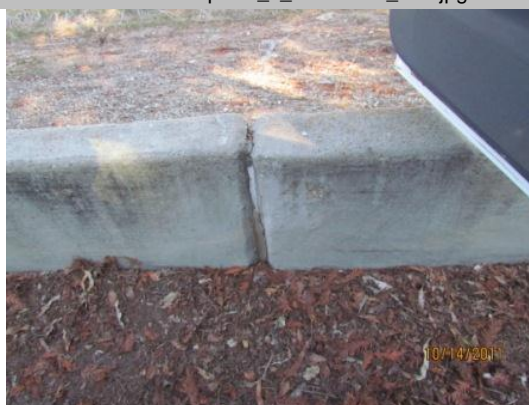
Photo 1 of 1 : pkazi_s_20140415_231.jpg

Monolith joint material is deteriorating at the joint of the flood wall. The picture was taken from the crown looking upstream.

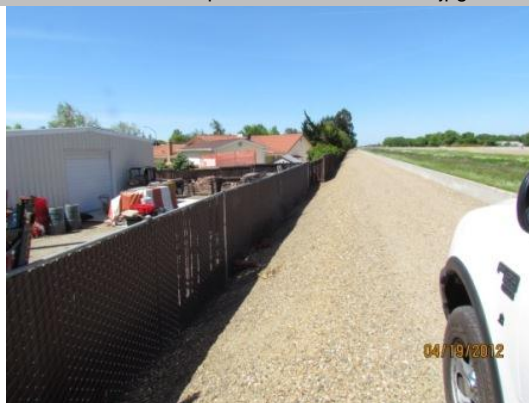
Photo 1 of 1 : pkazi_s_20140415_222.jpg

Fences were found on the landside of the levee looking downstream.

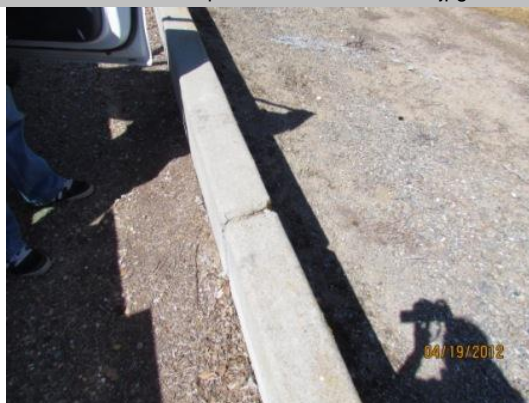
Photo 1 of 1 : pkazi_s_20140415_193.jpg

The monolith joint material is deteriorating on the waterside of the levee looking downstream.

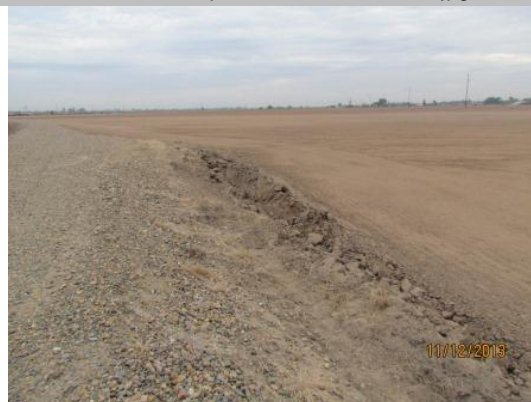
Photo 1 of 1 : pkazi_s_20140415_227.jpg

Slope instability was found on the landside toe of the levee looking upstream.

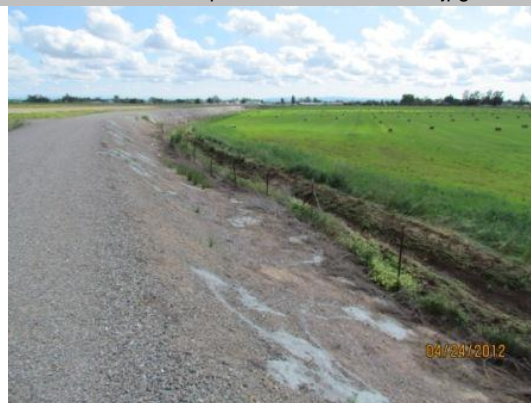
Photo 1 of 1 : pkazi_s_20140415_288.jpg

Fences were found on the landside toe of the levee looking upstream.

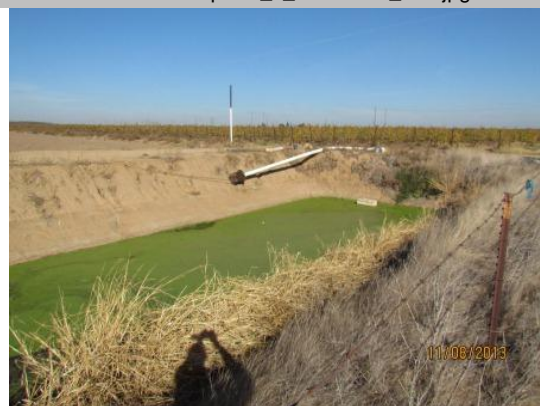
Photo 5 of 5 : pkazi_s_20140415_308.jpg

Updated picture of the ditch on the landside of the levee. The picture was taken during fall 2013 inspection looking upstream.

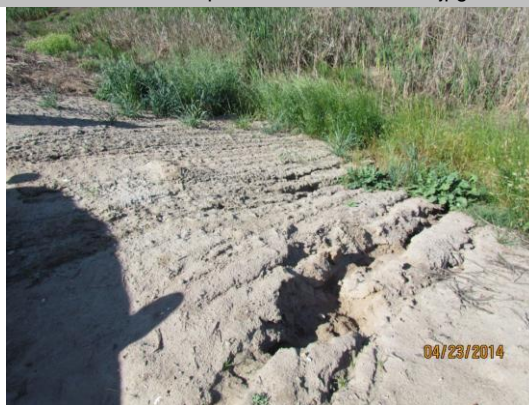
Photo 1 of 1 : pkazi_s_20140428_903.jpg

Erosion was found on the waterside slope of the levee looking downstream.

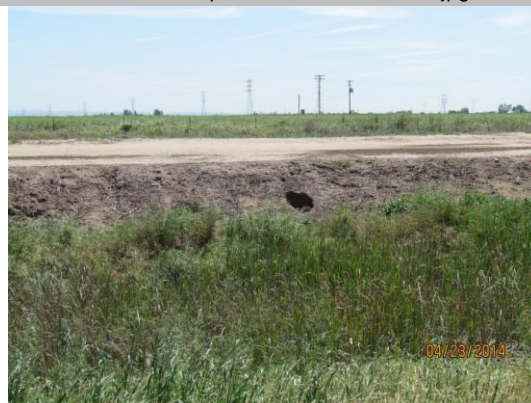
Photo 1 of 1 : pkazi_s_20140428_906.jpg

View of a rodent hole on the waterside slope of the levee. The picture was taken from the opposite side of the levee.

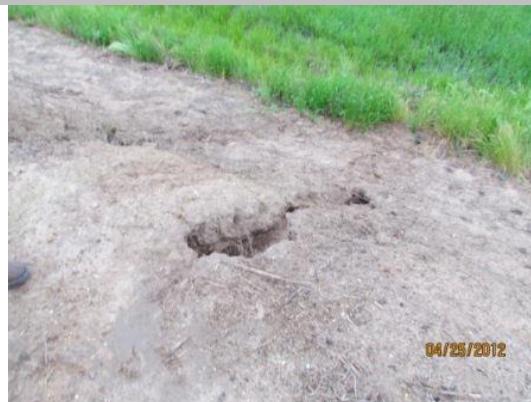
Photo 1 of 1 : pkazi_s_20140415_315.jpg

Erosion was found on the waterside of the levee looking downstream.

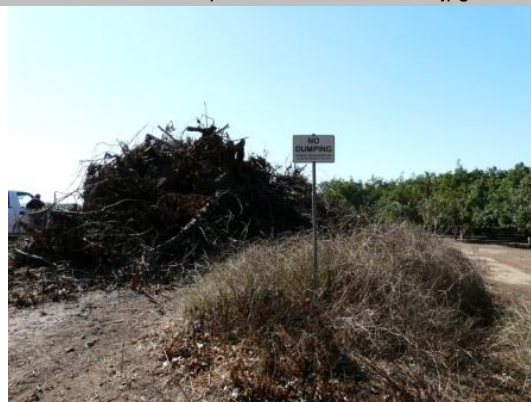
Photo 1 of 2 : pkazi_s_20140415_350.jpg

Example of a prunings pile immediately adjacent to access road at LM 4.29. Evidence of habitual burnings at this site.

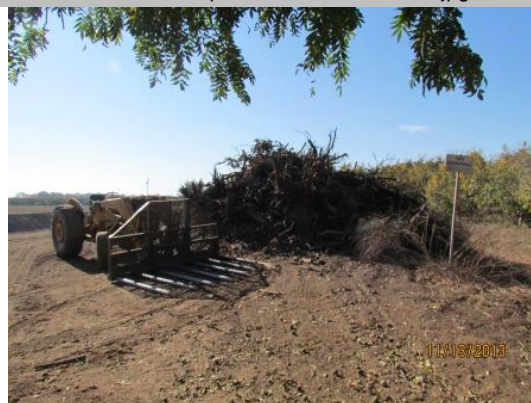
Photo 2 of 2 : pkazi_s_20140415_351.jpg

Updated picture of the prunings pile on the landside of the levee looking downstream during fall 2013 inspection.

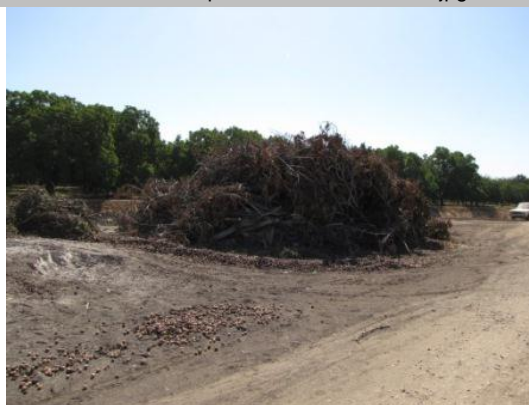
Photo 1 of 1 : pkazi_s_20140415_399.jpg

View of prunings pile along the waterward side of the crown looking downstream.

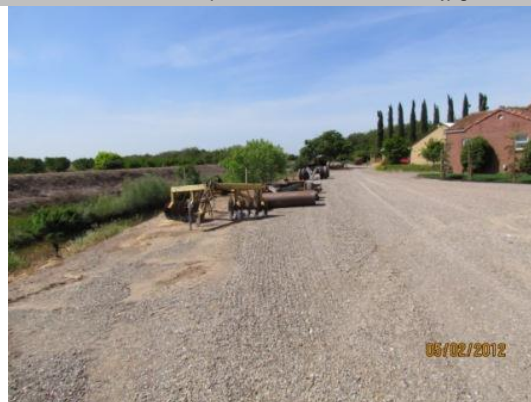
Photo 1 of 1 : pkazi_s_20140415_427.jpg

Equipment was found on the waterside of the levee looking downstream.

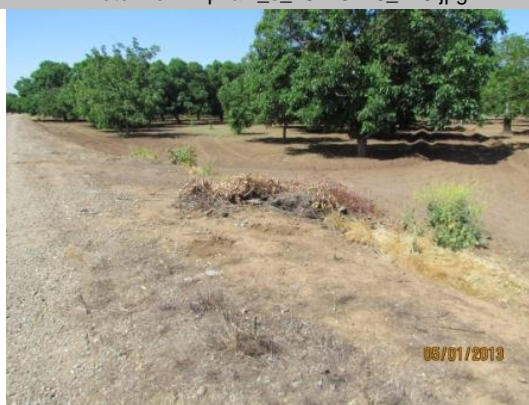
Photo 1 of 1 : pkazi_s_20140415_418.jpg

Prunings were found on the landside of the levee looking downstream.

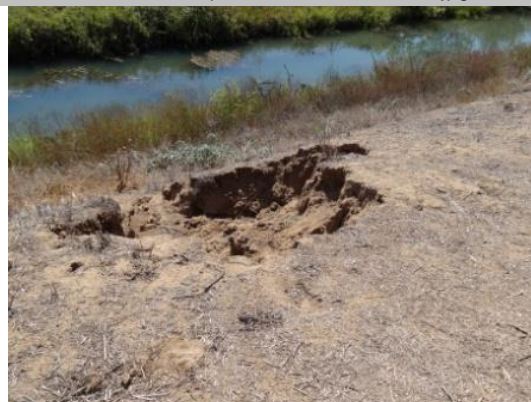
Photo 1 of 1 : pkazi_s_20140415_437.jpg

Looking down at the erosion from the levee crest.

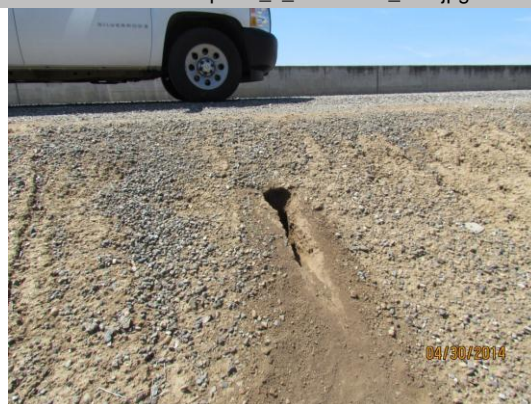
Photo 1 of 1 : pkazi_s_20140505_949.jpg

A rodent hole was found on the waterside of the levee looking downstream.

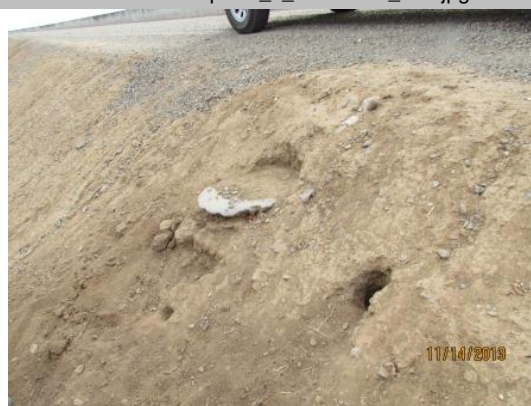
Photo 1 of 1 : pkazi_s_20140415_396.jpg

An animal hole was found on the landside slope of the levee looking upstream.

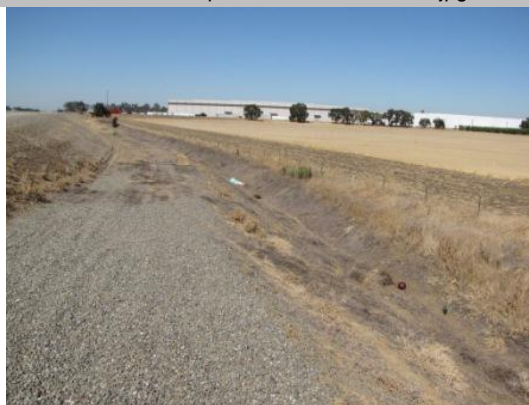
Photo 1 of 1 : pkazi_s_20140415_461.jpg

View of a ditch adjacent to the landward toe looking downstream.

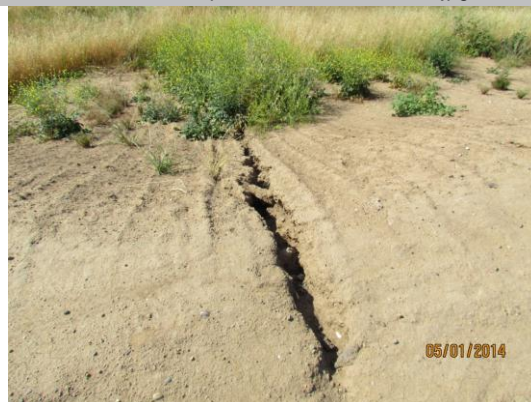
Photo 1 of 1 : pkazi_s_20140505_952.jpg

Erosion caused by runoff on the waterside of the levee looking downstream.

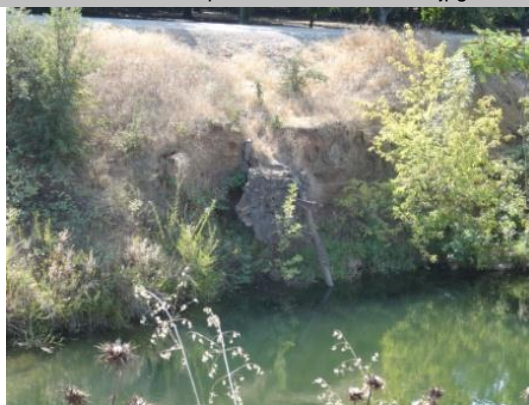
Photo 1 of 1 : pkazi_s_20140415_577.jpg

Front view of erosion.

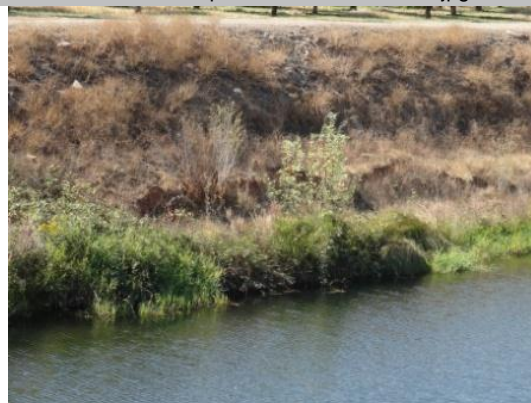
Photo 1 of 1 : pkazi_s_20140415_584.jpg

Close view at the erosion.

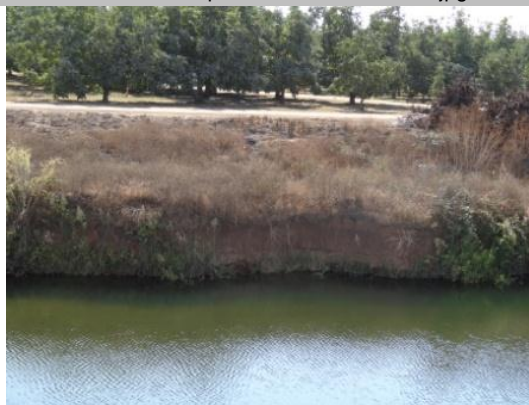
Photo 1 of 1 : pkazi_s_20140415_589.jpg

Front view of the erosion.

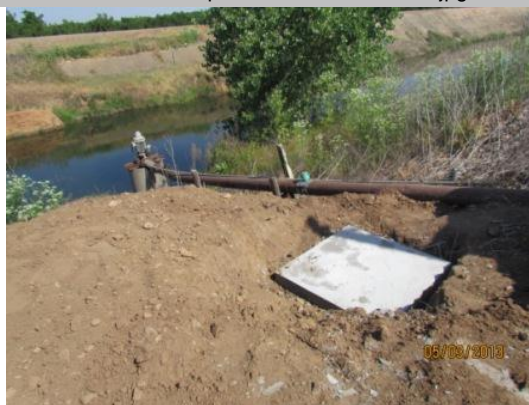
Photo 1 of 1 : pkazi_s_20140415_475.jpg

A concrete pad was found on the waterside shoulder of the levee looking upstream.

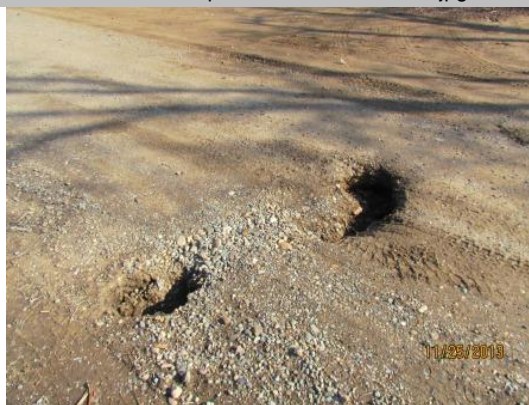
Photo 1 of 1 : pkazi_s_20140415_573.jpg

Rodent holes were found on the crown of the levee looking upstream.

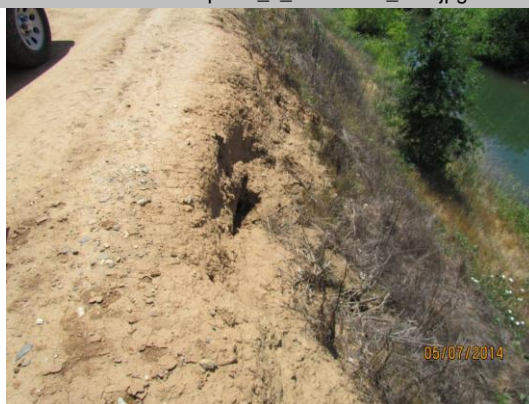
Photo 1 of 1 : pkazi_s_20140512_975.jpg

A rodent hole was found on the waterside shoulder of the levee looking downstream.

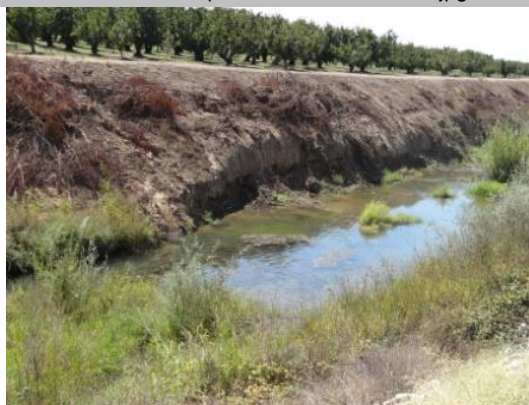
Photo 1 of 1 : pkazi_s_20140415_615.jpg

Close view of erosion.

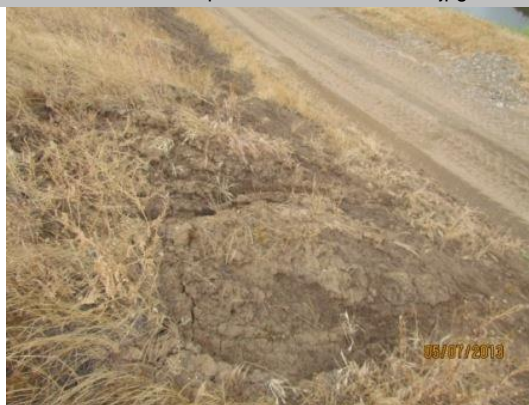
Photo 2 of 2 : pkazi_s_20140415_551.jpg

Slope instability was found on the waterside slope of the levee looking downstream.

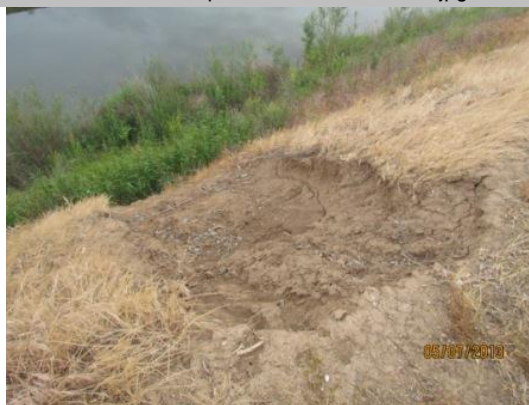
Photo 2 of 2 : pkazi_s_20140415_552.jpg

Erosion was found on the waterside slope of the levee looking upstream.

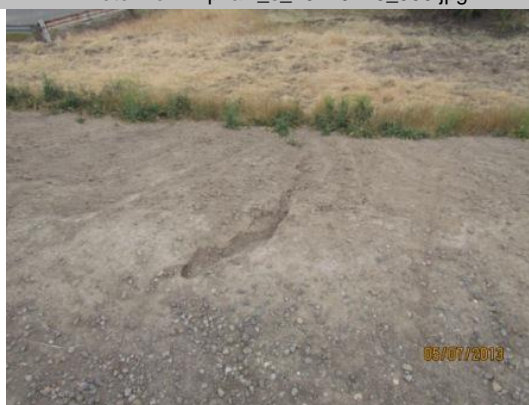
Photo 1 of 2 : pkazi_s_20140415_566.jpg

Erosion was found on the landside of the levee looking upstream.

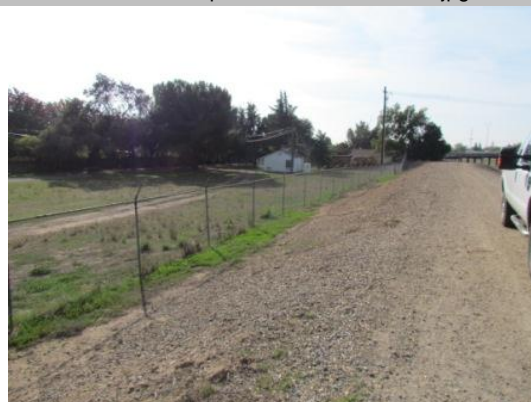
Photo 1 of 1 : pkazi_s_20140415_556.jpg

Wire fence was found on the toe of landside of the levee looking downstream.

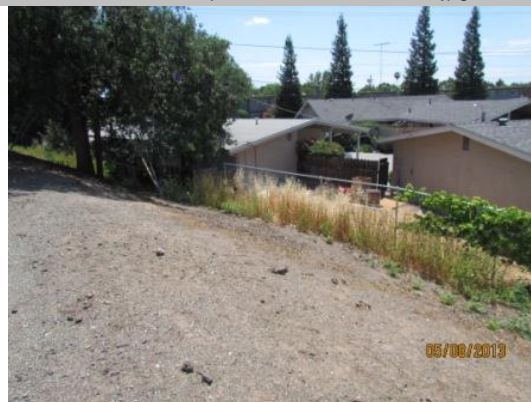
Photo 1 of 1 : pkazi_s_20140415_484.jpg

Fence was found on the landside toe of the levee looking upstream.

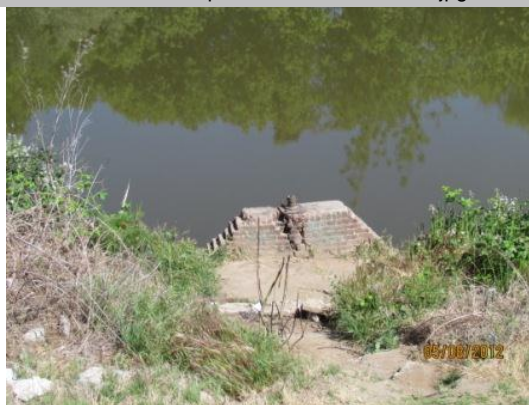
Photo 1 of 1 : pkazi_s_20140415_511.jpg

A retaining wall was found on the waterside toe of the levee looking upstream.

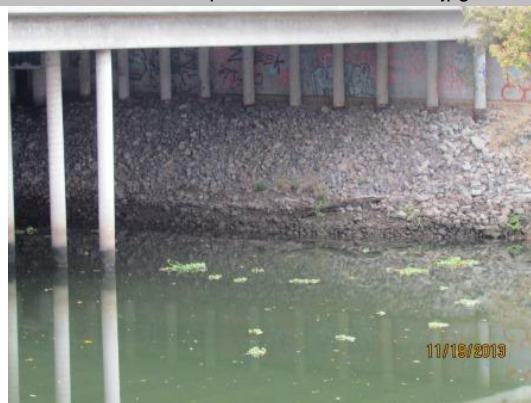
Photo 1 of 6 : pkazi_s_20140415_497.jpg

Updated picture of erosion was found on the waterside toe of the levee looking from the opposite side of the levee.

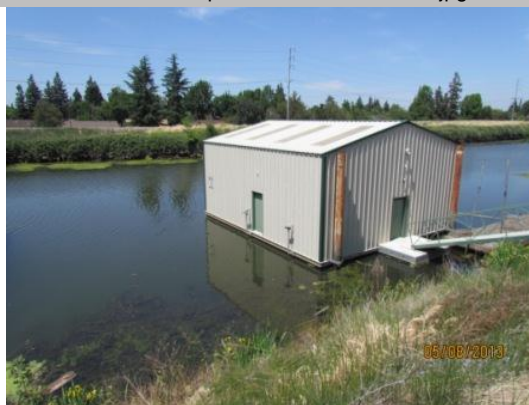
Photo 1 of 1 : pkazi_s_20140415_607.jpg

A dock was found on the waterside toe of the levee looking upstream.
